Manhole Inspection Summary

Manhole # **S19C__039MH**

Record Plat: **19C** Node: **039** Status: **New Manhole (Not in GIS)** Insp Date: **10/15/07 12:00 AM**

Location Address: **513 PULASKI-BRICE**

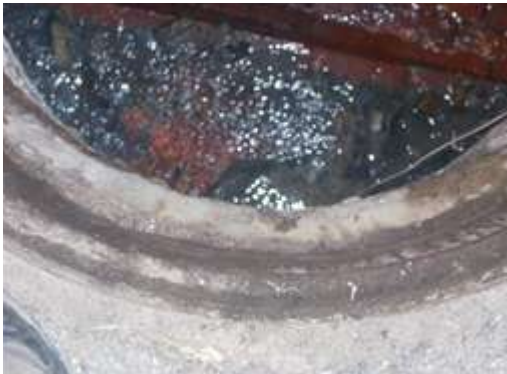
Defect 2

Offset: **2** (in.)

FRAME OFFSET

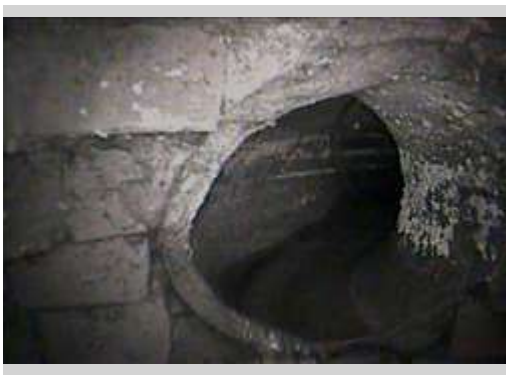
Top View

PIPE BENDS

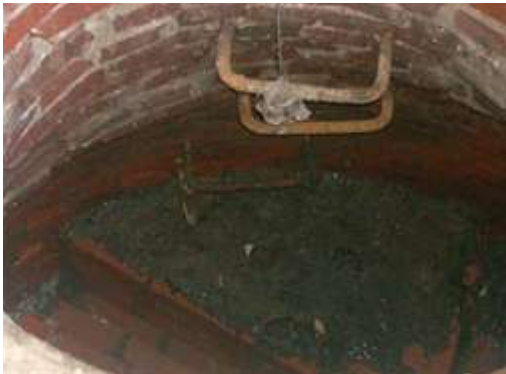
Defect 1

☒ **Evidence Of Surcharge** Depth: **2** (ft.) ☐ Active Surcharge Present

SURCHARGE EVIDENCE ON STEPS

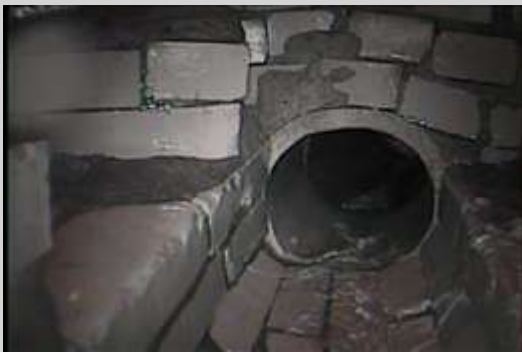
12 O'Clock Outflow

8 in. Circular Gravity Sewer
Pipe Out @ 12 O'Clock

Pipe Height: **8.4** (in.) Rod and Bar (Angled)
Pipe Material: **Clay** ☐ Pipe Lined
Invert Depth: **7.01** (ft.) Flow Characteristics: **Slow**
Deposits: ☒ None ☐ Mud ☐ Sludge ☐ Debris ☐ Grease
Silt Depth: (in.) Deposits Extent:
Infiltration: **None** Pipe Seal Cond: **Sound**

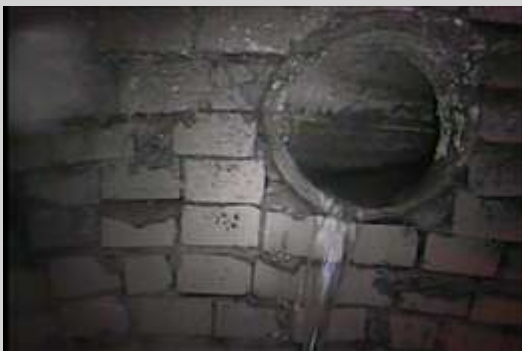
5 O'Clock Inflow

8 in. Circular Gravity Sewer
Pipe In @ 5 O'Clock

Pipe Height: **8.4** (in.) Rod and Bar (Angled)
Pipe Material: **Clay** ☐ Pipe Lined
Invert Depth: **4.45** (ft.) Flow Characteristics: **Slow**
Deposits: ☒ None ☐ Mud ☐ Sludge ☐ Debris ☐ Grease
Silt Depth: (in.) Deposits Extent:
Infiltration: **None** Pipe Seal Cond: **Sound**

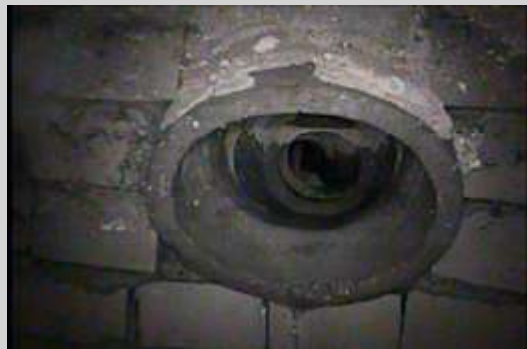
10 O'Clock Inflow

6 in. Circular Gravity Sewer
Pipe In @ 10 O'Clock

Pipe Height: **6** (in.) Rod and Bar (Angled)

Invert Depth: **3.87** (ft.) Flow Characteristics: **None**

Infiltration: **None**

Pipe Seal Cond: **Sound**
